Remedial Action Plan 3rd Line Berms

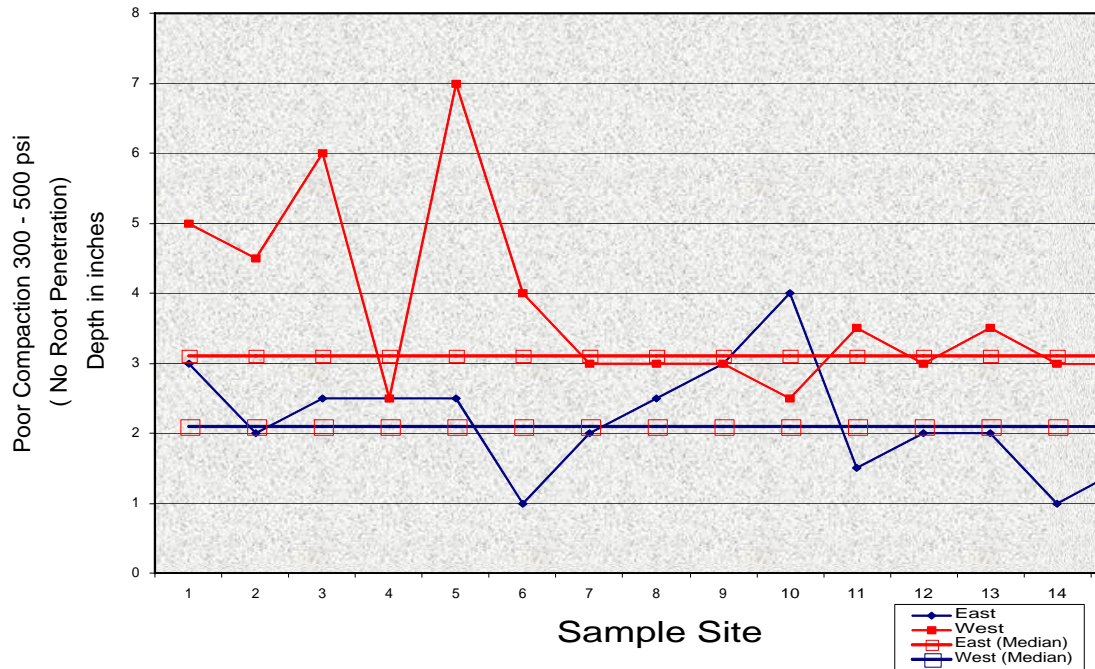
Figure 1: Soil compaction was measured in the following manner:

0-200lbs	good
200-300lbs	fair
300-500lbs	poor (No root penetration)

Test readings of soil compaction on these plots ranged from poor (300-500lbs psi. or the level at which roots cannot penetrate) at 1 - 7 inches, with the median depth being 2.1 inches on the east side and 3.1 inches on the west side (Figure 1). Overall compaction on this site is severe.

1) Radial trenching is one means of improving soil compaction and quality. This involves digging trenches 4 to 18 inches wide and 10 to 24 inches deep, removing existing soil and back filling with good quality soil or amended soil. Soil amendments could include sand, peat moss, perlite, vermiculite, water retaining granules, compost, mulch, or any combination thereof. When carrying out radial trenching, it is important to start the trench 6 inches away from the trunk of the tree for every inch of tree diameter (ie: a 20 inch diameter tree trench should start 10 feet from trunk).

2) Use good quality soil or amended soil on the top 24 inches of a planting site. The accepted industry standard for a growing medium is a sandy loam where sand content is 50%.(70% preferred).

3) Mulch each tree to the drip line with a 3 to 4 inch layer of good quality mulch made up of 1 inch size chips mixed with composted leaf and yard waste. (Do not use bark chips).
